Paul Scherrer Institut
Lukas Stingelin for the PSI rf-group
RF Operation and Developments at PSI

- **Operation Statistics**
- **LINAC Problems and Upgrades**
- **500MHz Klystron Problems**
- **Problems with Instabilities**
- **Cavitation analysis of input power coupler**
- **Commissioning of RF-Systems for the SwissFEL**

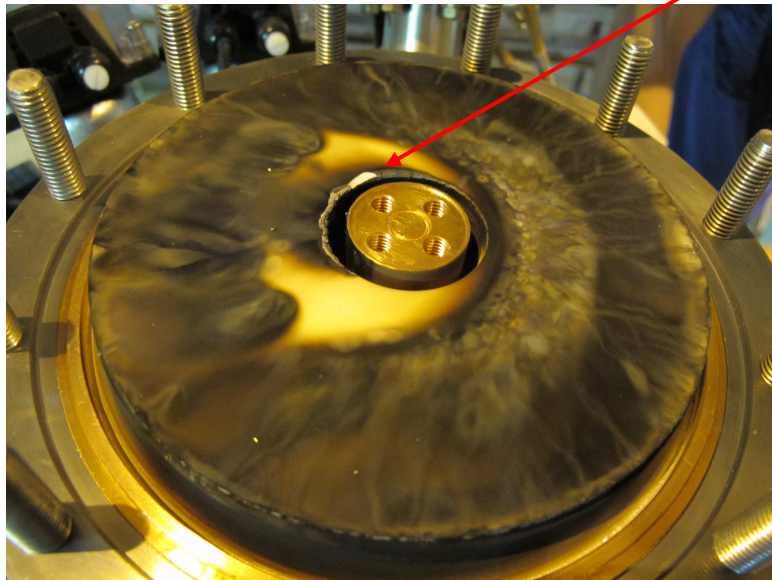
Ceramic of Input Power Coupler with cracked chamfer

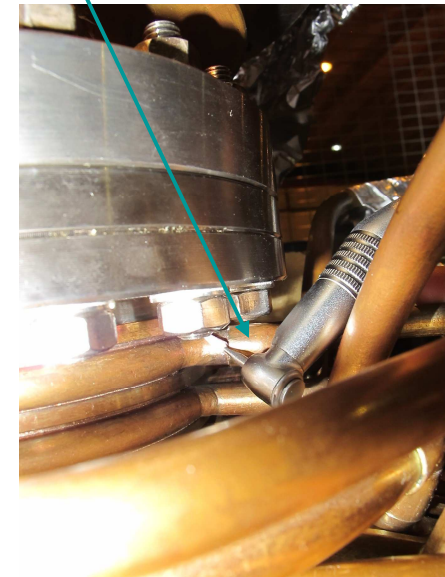
Dentist-tool to repair water-leaks:

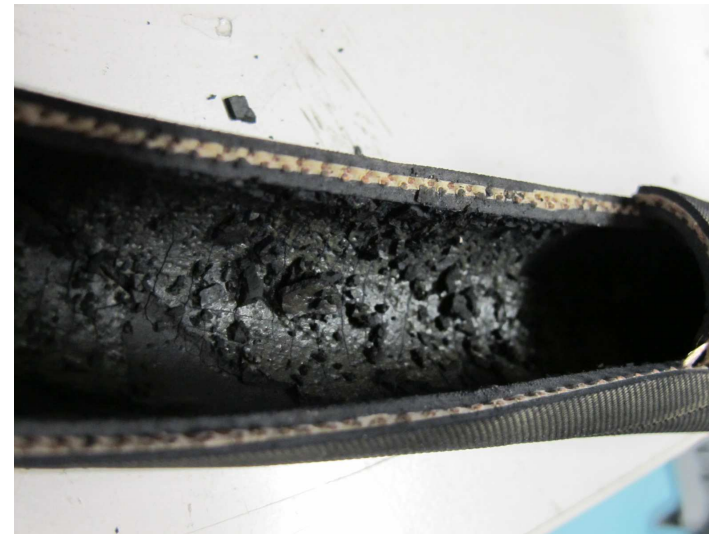
- ❑ Problems with rubber hoses in „open“ cooling-circuit for the LINAC structures:

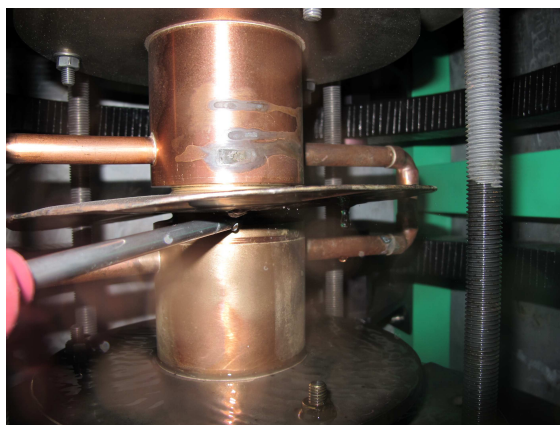
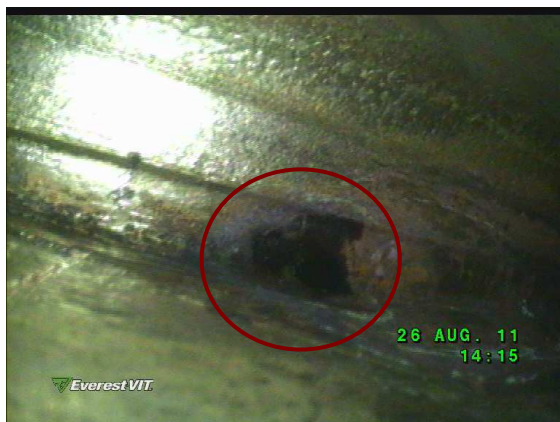
- ☒ Water leak at first refurbished klystron after 6 months of operation

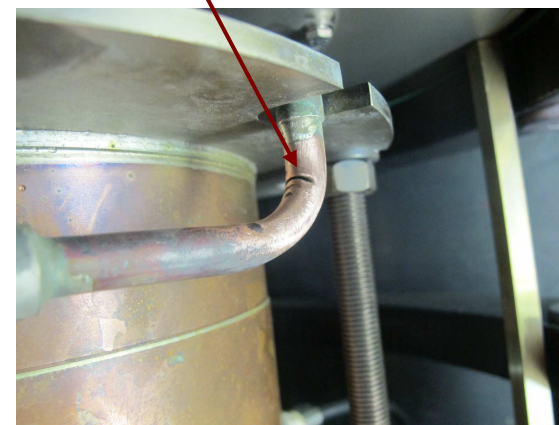
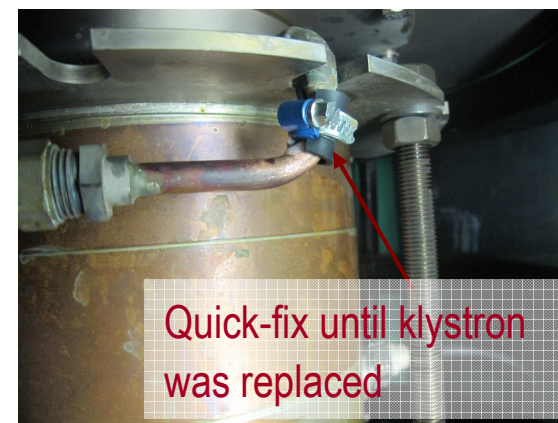
- ☒ Water leak at booster klystron

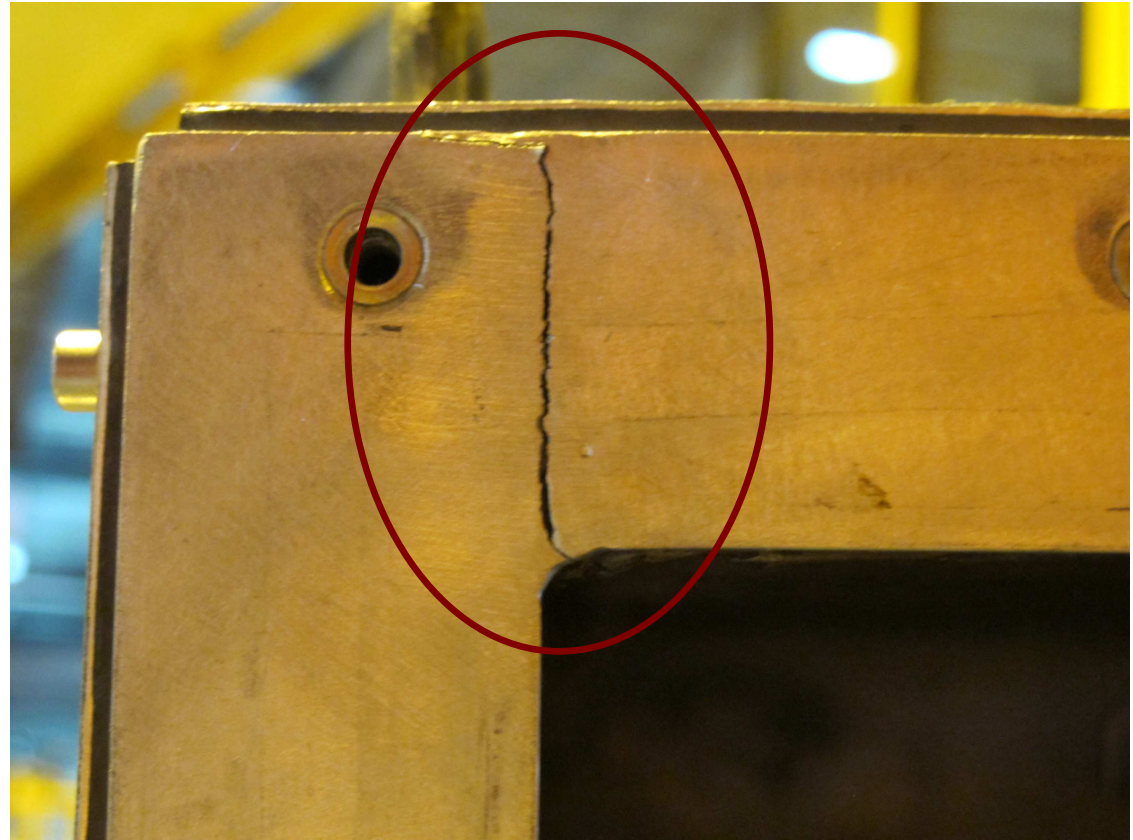
☒ Fissures at frame of HV-box (→ temporary fix with bands and successive replacement by rewelded + reinforced frame)

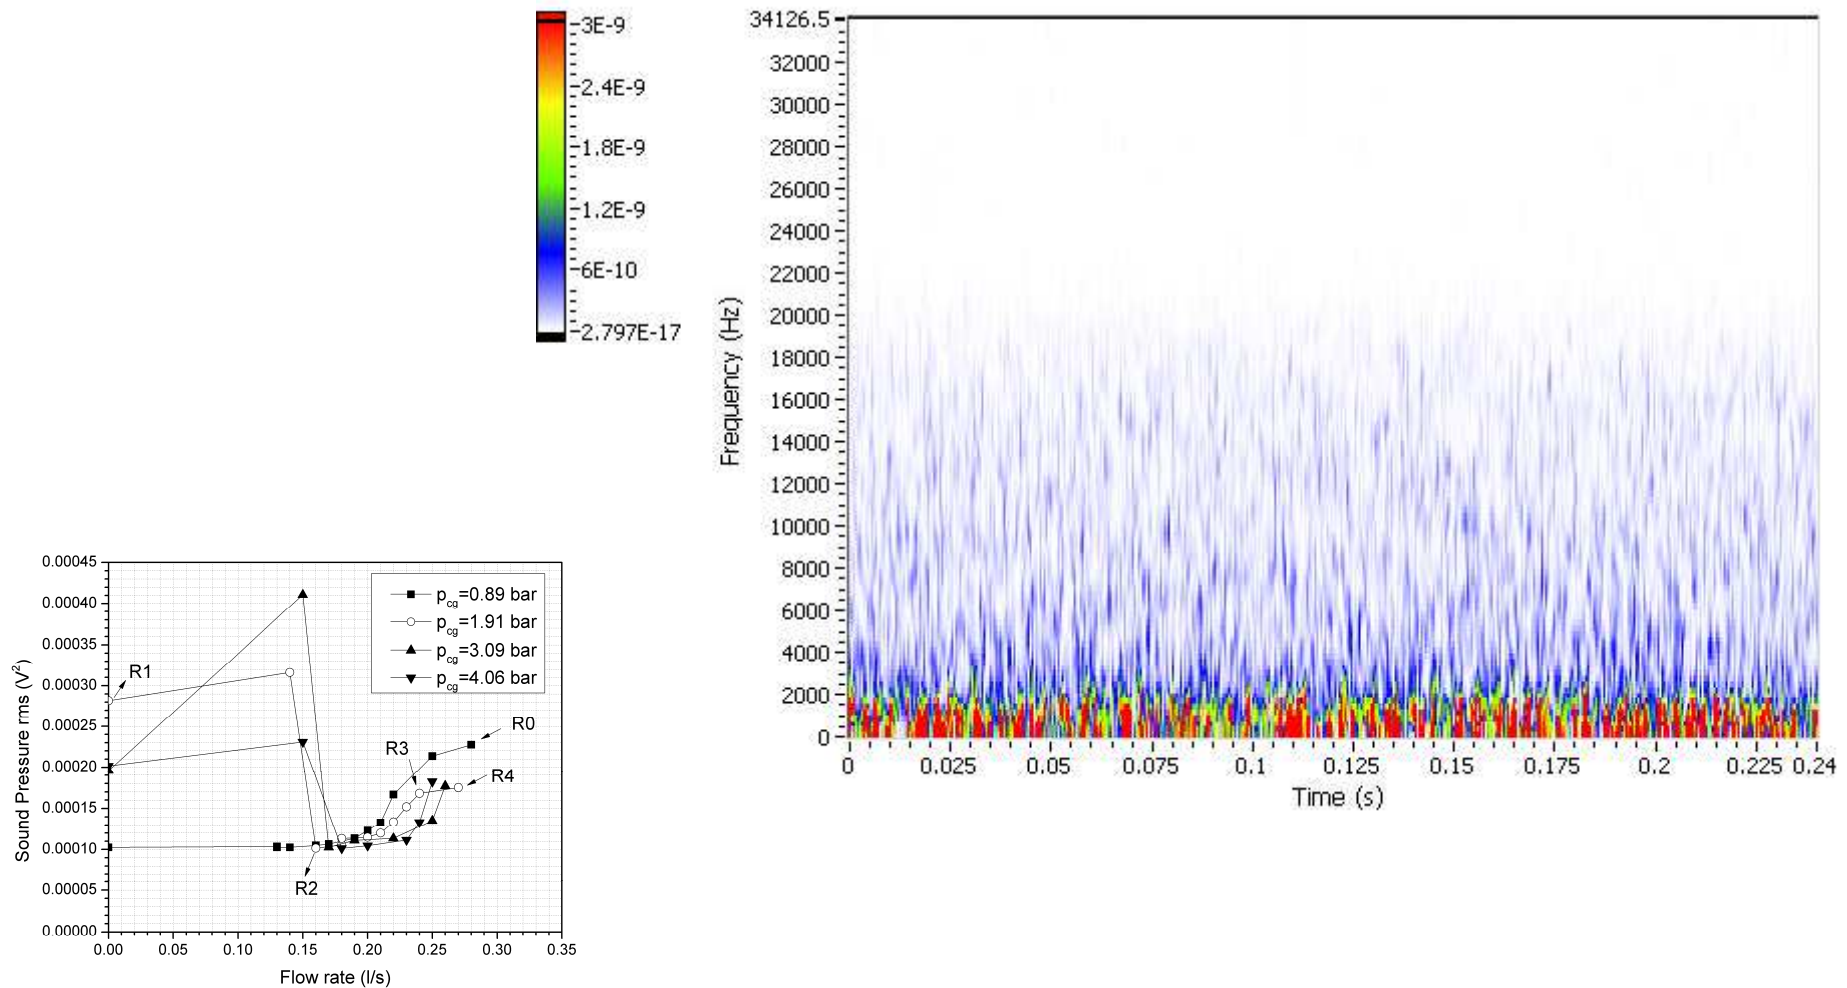
Regime 2 (1.91bar, 0.16l/s) → no cavitation

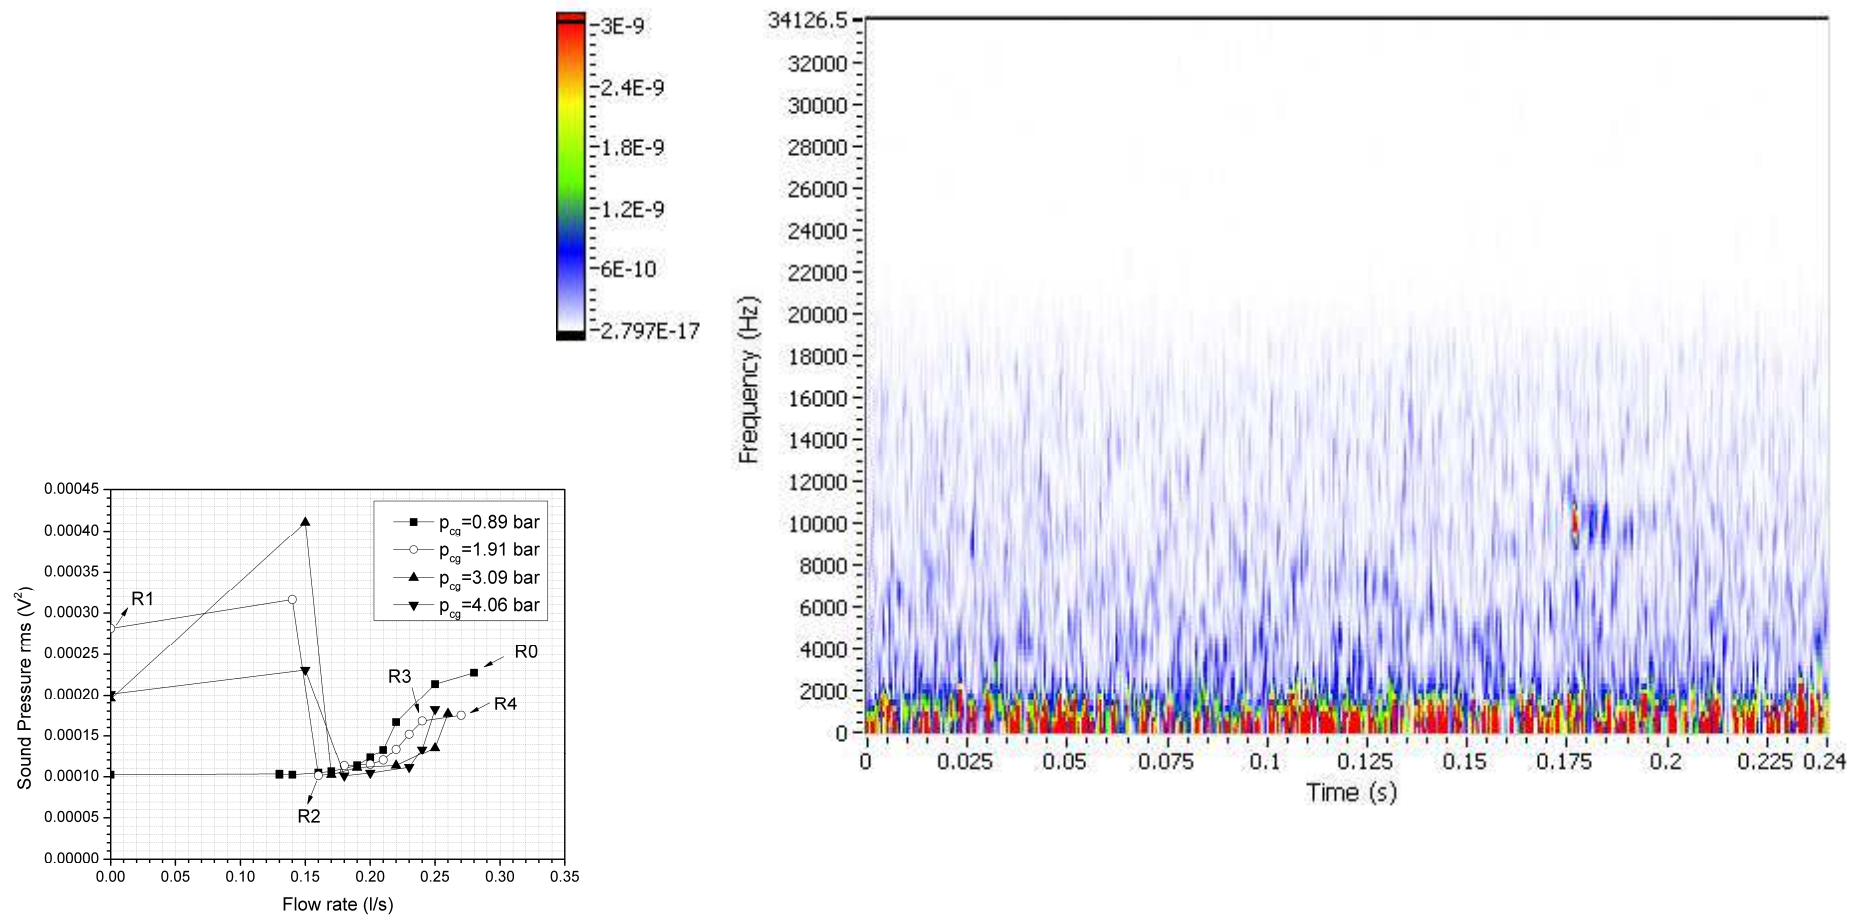
Regime 3 (1.91bar, 0.24l/s) → incipient cavitation

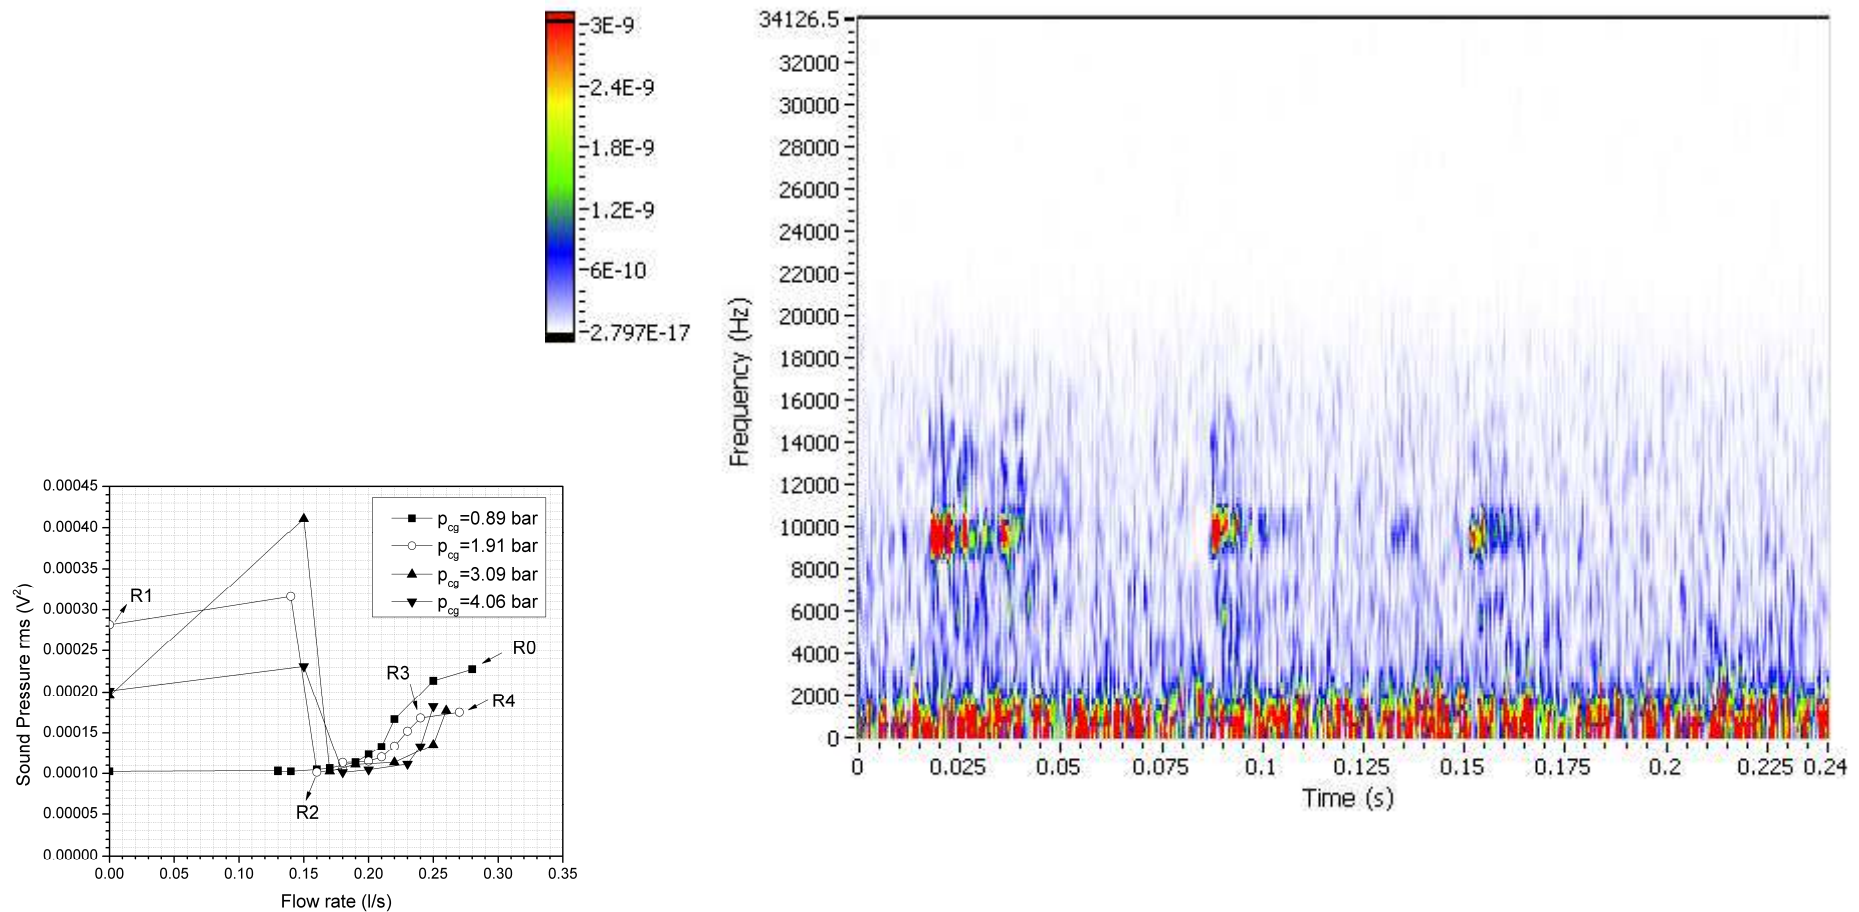
Regime 4 (1.91bar, 0.27l/s) → cavitation

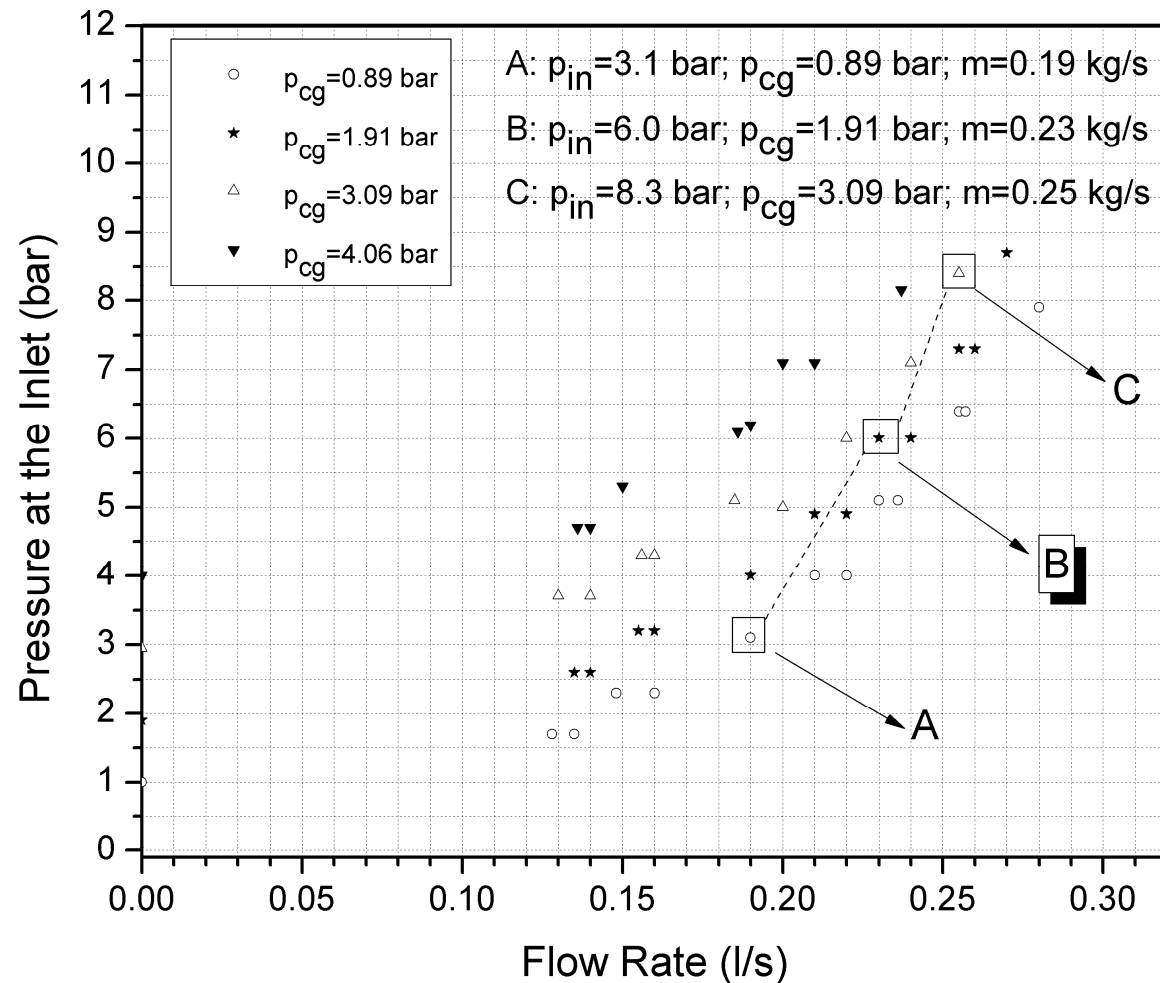
Limit of Cavitation

Pressure of the inlet as function of the flow rate for different pressures of the cover gas .

Capital letters indicate where incipient cavitation was detected

Higher pressure helps to avoid cavitation!

**Operation now:
@ 0.07 m/s**
