# One year operation of ALBA IOT's

Jesús Ocampo on behalf of RF team:

1. Overview of ALBA RF transmitters
2. Interlocks and hours of operation
3. Incidents
  - Broken tubes
  - IOT detuning

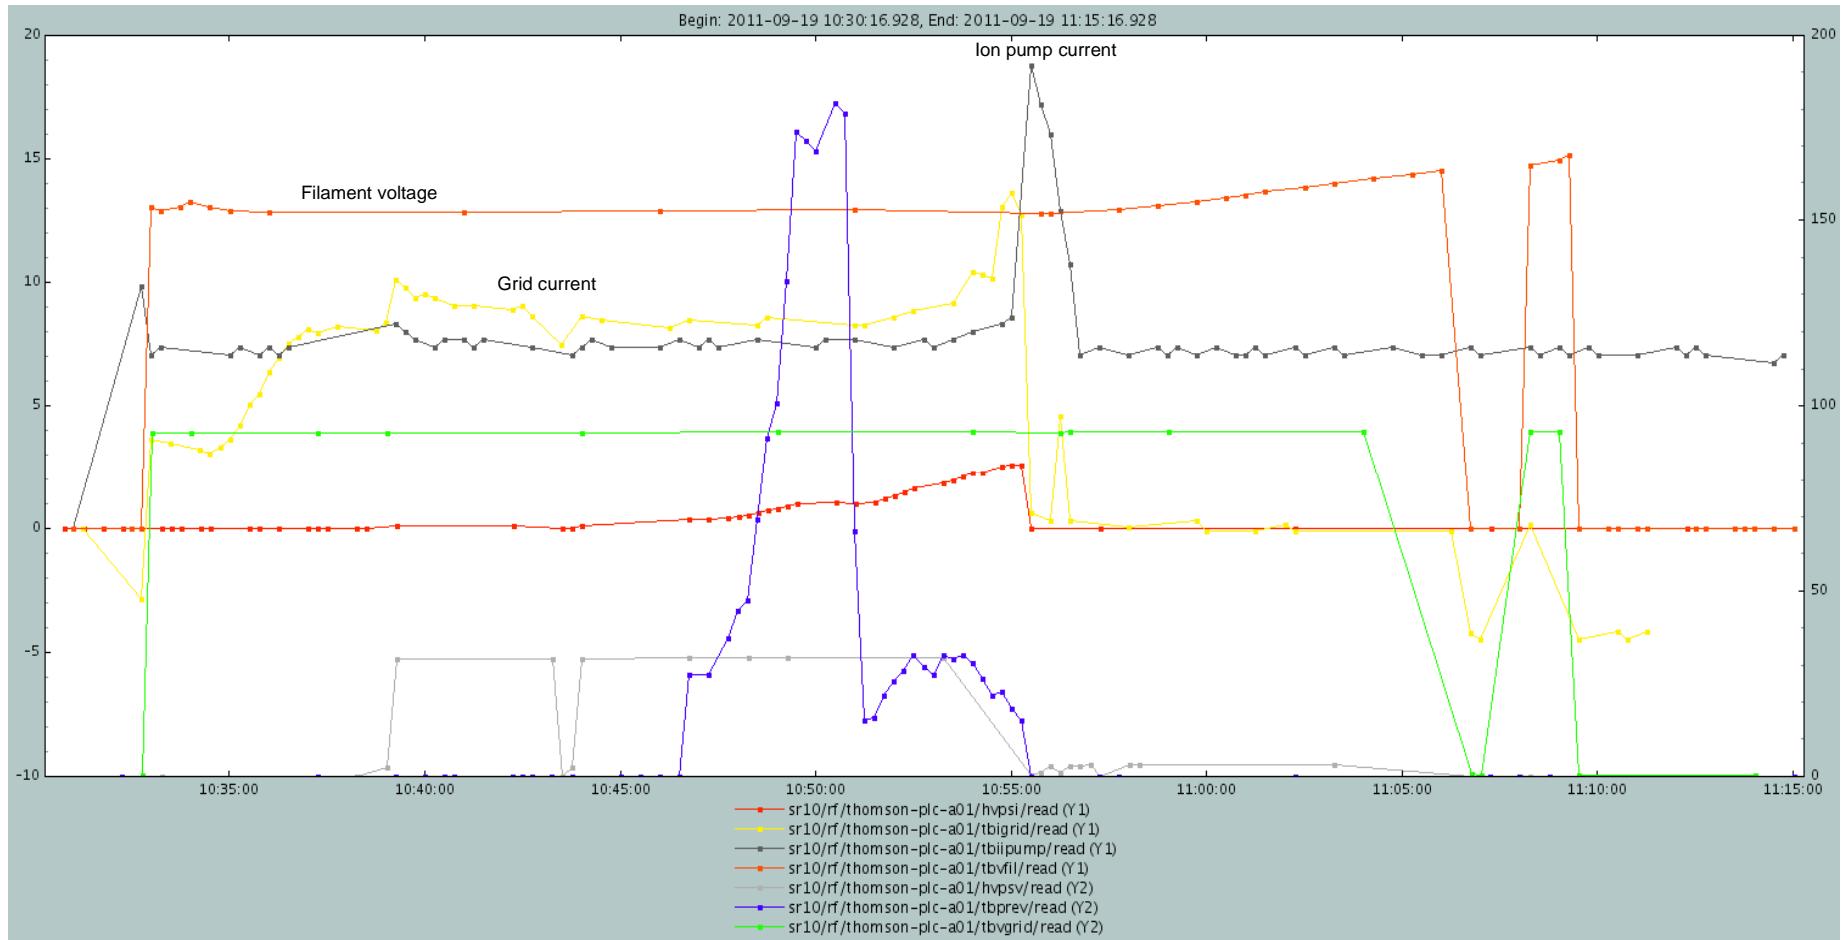
**Broken tube #1**

# Broken tube #1

- Solutions:

- Keep ion pump on all the time
- Startup procedure
  - HV conditioning
  - Pulsed RF conditioning
  - CW RF conditioning
